APR Safety Repair Action: SRA0001

Subject: Service Repair Action: APR-RK0001
APR V8 FSI Supercharger & Stage 4 Low Pressure Fuel Pump Kits
Fuel Line Inspect & Replace If Necessary.

Identification of defective components.

Inspection Points on APR Supercharger Kits

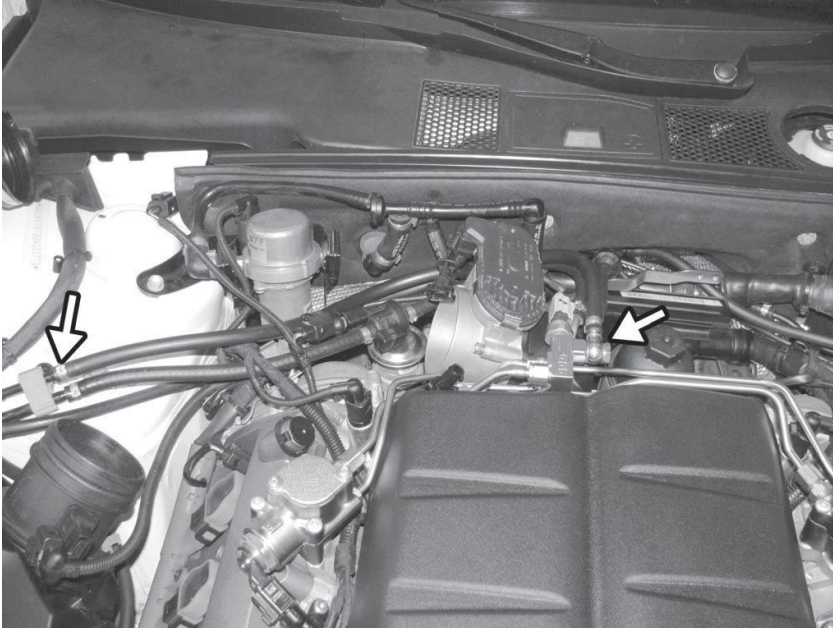
The Picture Below shows both of these lines coming from the OEM connections on the Passenger Side Shock Tower and routing behind the APR Supercharger unit with the throttle body hose removed for easy visual. The left Arrow shows the location of the vacuum and fuel feed line barb connection, and the right arrow shows the connection for the fuel line to the APR fuel distribution block.

On the APR Supercharger kits, the supplied fuel line was installed on the connection for the OEM N80 valve to the vacuum line barb on the passenger side forward shock tower and also from the N80 valve to the inlet neck of the APR Supercharger unit. Some may find it easier to inspect these lines by removing the throttle body hose as the lines reside directly under this item. Also the Fuel line was used to connect the fuel feed barb next to the N80 valve vacuum line barb to the APR Fuel distribution block directly behind the APR Supercharger manifold.

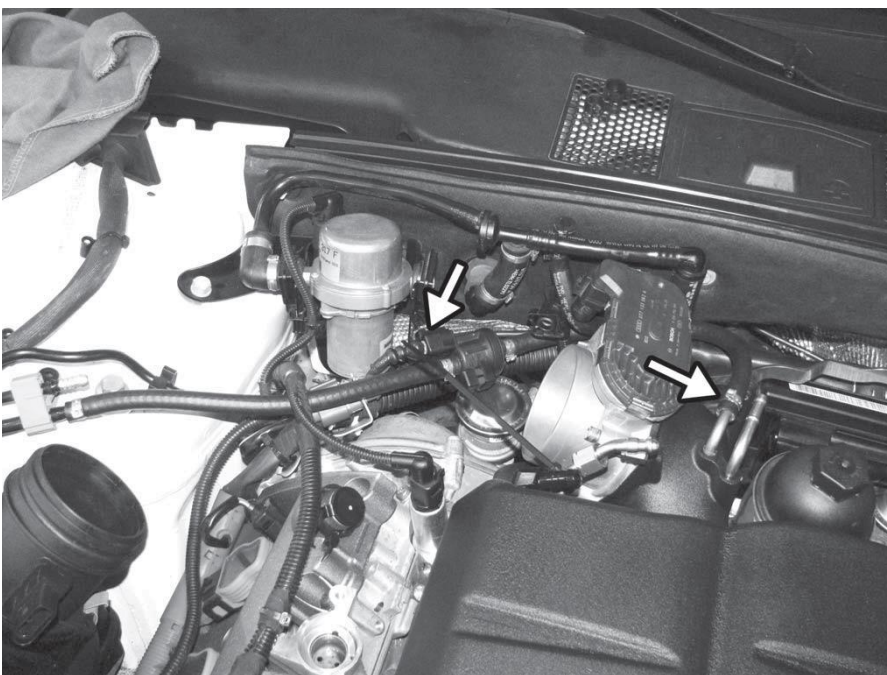
The next picture shows the connection at the inlet neck of the APR Supercharger for the N80 valve line connection. The arrow in the center shows the N80 Valve and where it sits. The arrow on the right of the photo shows the lines connection at the barb on the inlet of the APR Supercharger.

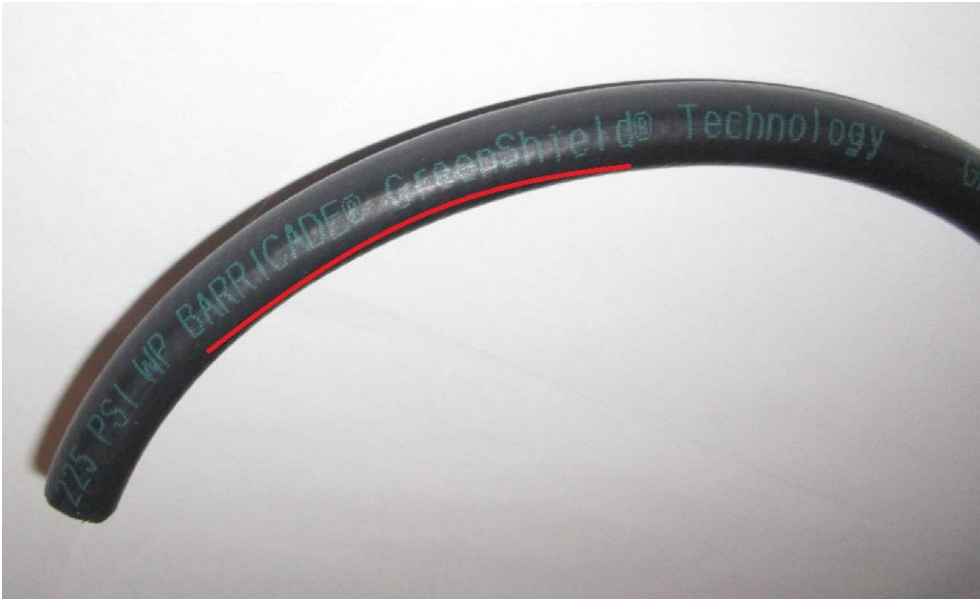
First roll the fuel line around so that you can see the Green writing on the fuel line. Look down the length of the fuel line to see if it is labeled with "Barricade© GreenShield©." If either fuel line is labeled with this writing, as shown in the image below, please proceed to the next section. If the fuel line doesn't have any green writing or does not have the branding for "Barricade© GreenShield©," then you may reassemble the vehicle and inspection is complete. Repairs will not be needed on this vehicle.

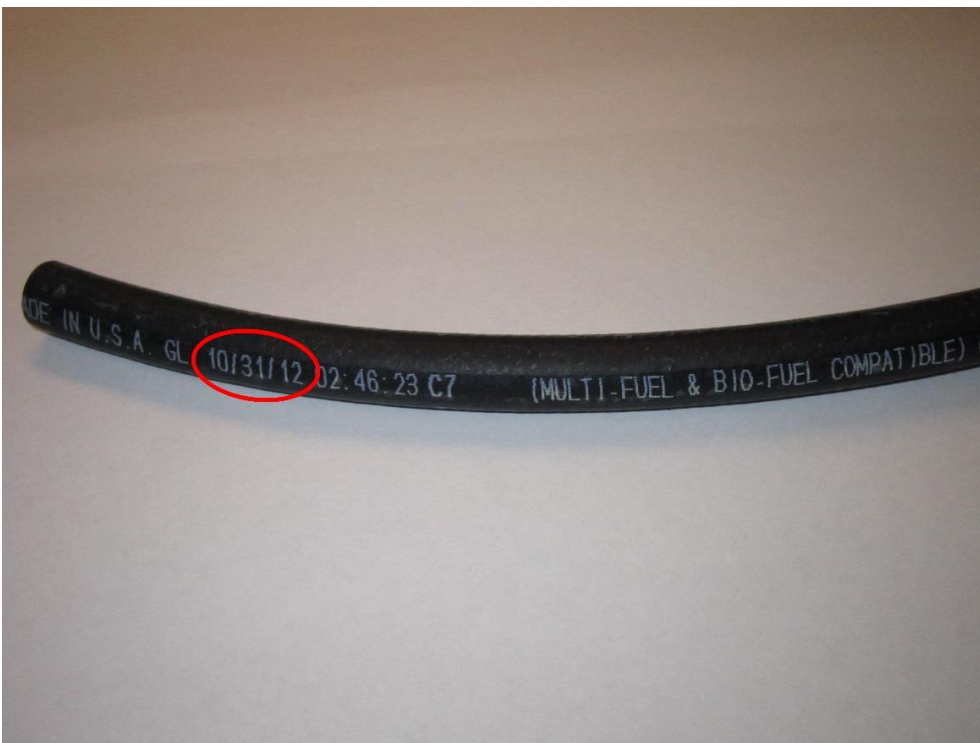
Next roll the line around and look for a manufacturing date stamped onto the fuel line. It will be in this format "MM/DD/YY" and is generally preceded by "U.S.A. GL" and following it will be another string of numbers. The picture below shows a section of the line outside of the vehicle with this information displayed.

If the fuel line is branded with "Barricade© GreenShield©" and dated at or before 04/30/12, then all fuel lines included with the APR kit will need to be replaced using the supplied repair kit at the beginning of this document. Note, you will only want to replace the fuel lines that are installed with the APR kit. DO NOT REPLACE the OEM fuel lines. Also note that this is general repair kit so you may have some sections of hose and extra clamps left over after the replacement is complete as this kit is designed to fit all models for simplicity.

If the fuel line is either not branded with "Barricade© GreenShield©" or branded with "Barricade© GreenShield©" and dated at or after 05/01/12, then these fuel lines do NOT need to be replaced. At this point, you can reinstall any removed components and return the car to the customer.
