## Installation instructions For set # 3.3188 2004 Pontiac GTO

## Parts list:

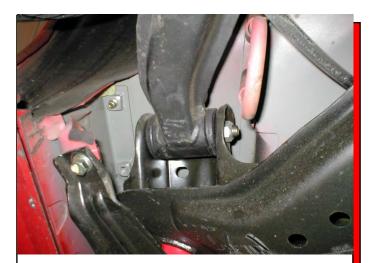
The outer position bushing has no outer metal shell that needs to be pressed out. The I.D. of control arm is Ø1.608, use something smaller when pressing out the old bushing. The O.E. rubber bushing is not bonded to the control arm. Trim off the flanges of the rubber bushing (both sides) and press out the bushing. Apply grease to all metal parts that contact the polyurethane bushings. Grease P/N's 2595 and sleeve P/N 15.10.180.39 and insert into the control arm.

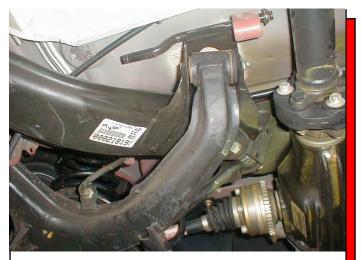
The inner position bushing has an outer plastic shell that needs to be pressed out. The I.D. of control arm is Ø1.608, use something smaller when pressing out the old bushing. Trim off the plastic flange of the shell and press out the bushing. Apply grease to all metal parts that contact the polyurethane bushings. Grease P/N's 2598 and sleeve P/N 15.10.180.39 and insert into the control arm.
