## **Installation Instructions**

For set # 7.3118 00-03 NISSAN MAXIMA FRONT CONTROL ARM BUSHING

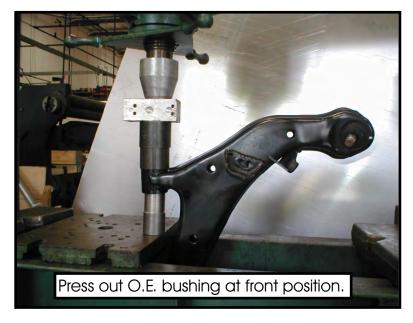
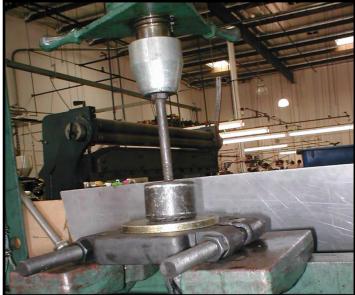
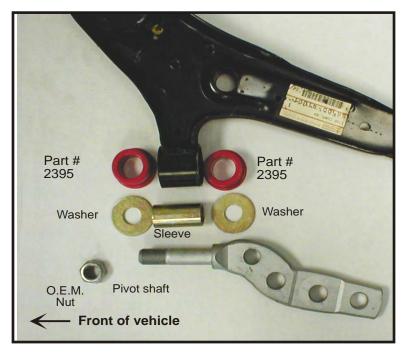
Press out O.E. outer metal shell from aluminum bracket, then press pivot pin on control arm out of bushing. A pressed fit sleeve will then need to be removed. Grease all metal parts that will touch bushing # 3447. Part numburs faces the rear.

The sleeve will need to come off the rear pin. It's a tight press fit. With a hammer and chisel, make a groove along its length, this will relieve the press fit. The sleeve will then slide off by hand.
