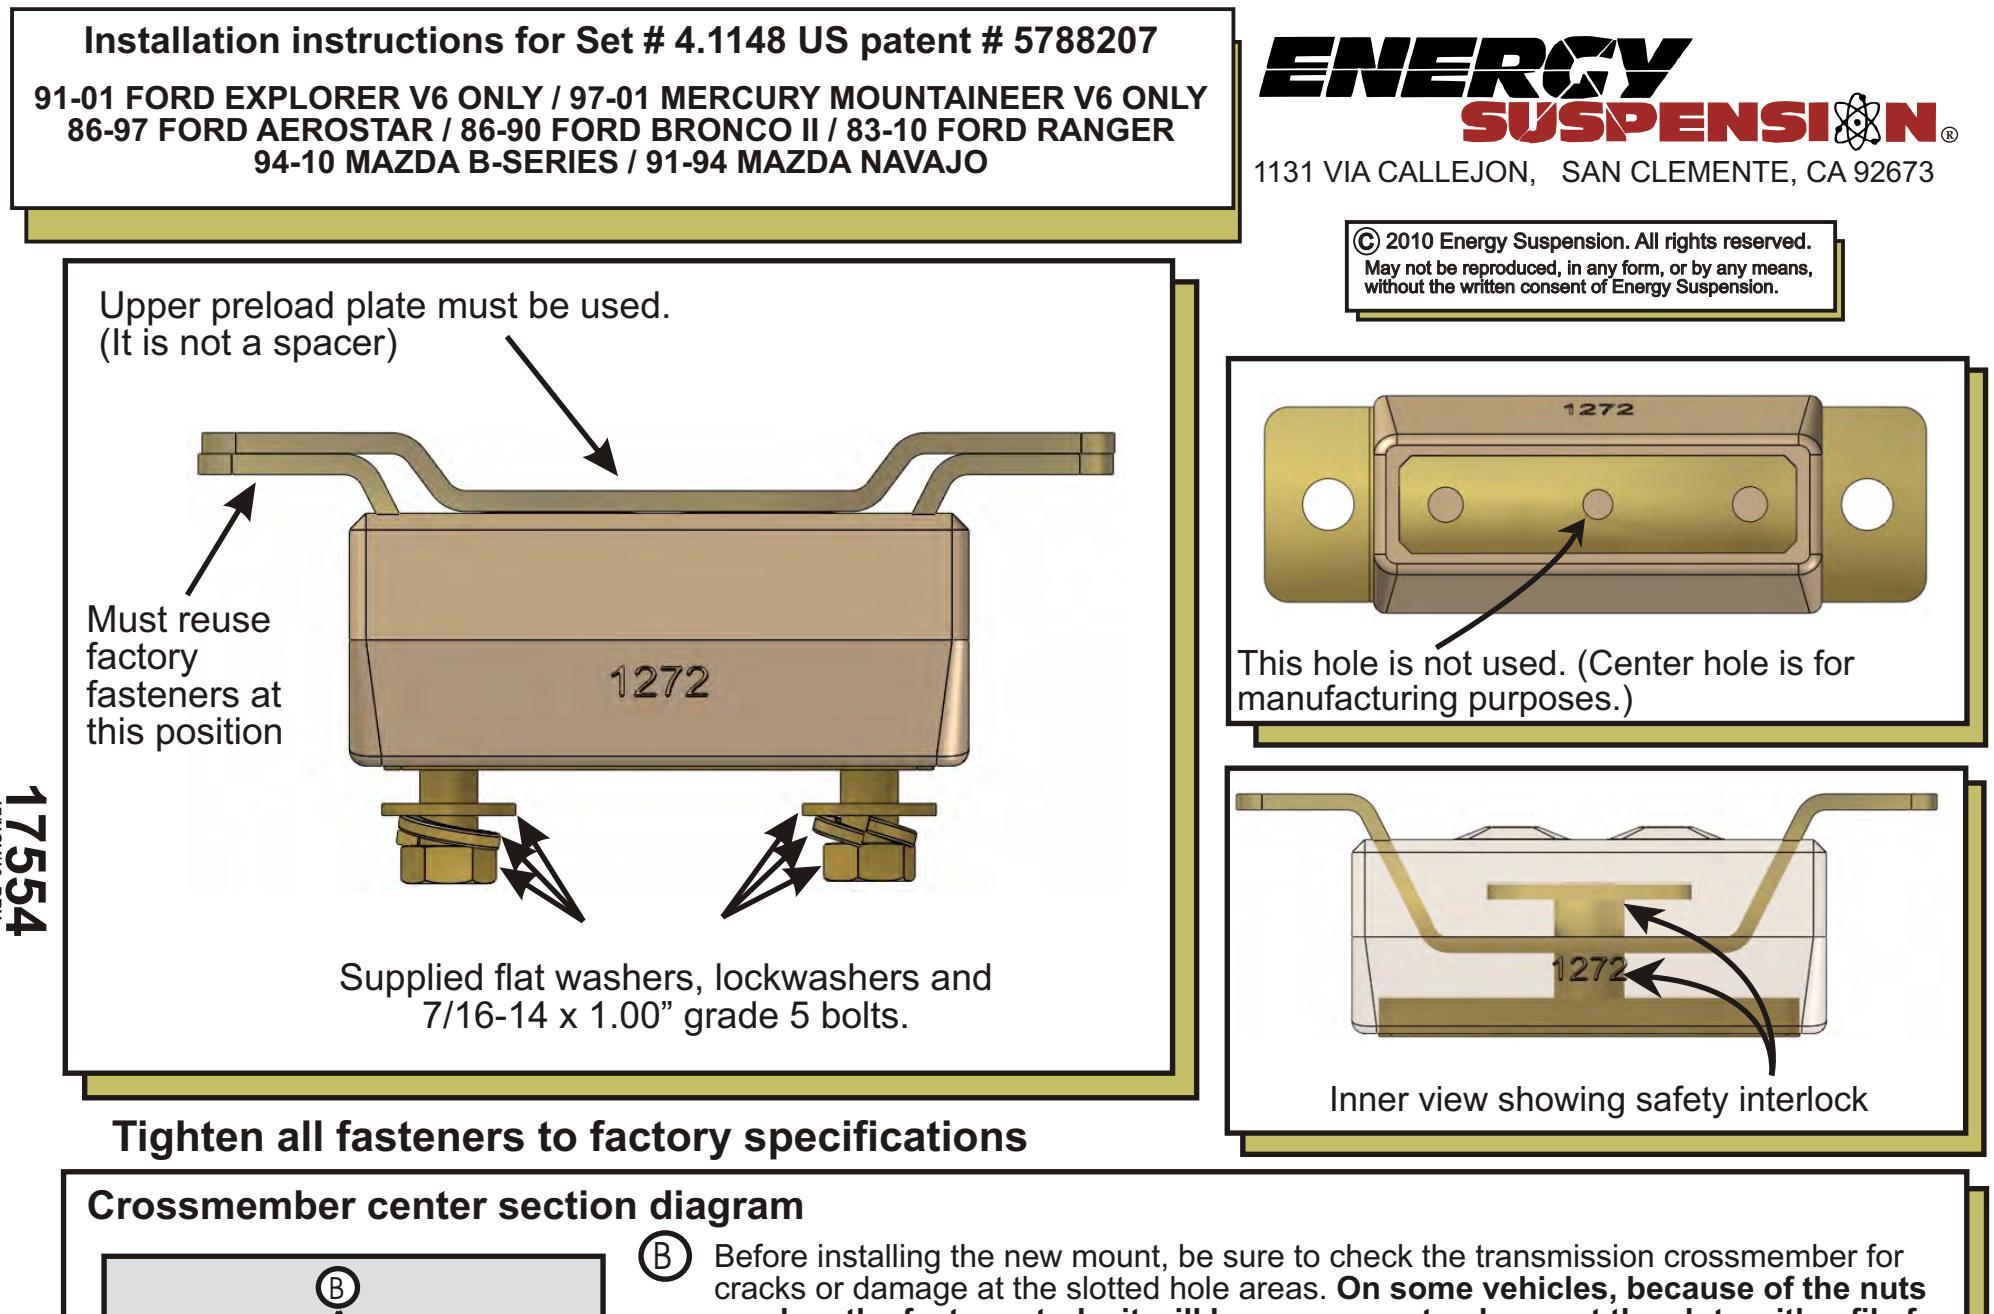
cracks or damage at the slotted hole areas. On some vehicles, because of the nuts used on the factory studs, it will be necessary to clean out the slots with a file for clearance when using the new bolts. Repair or replace the crossmember if any damage is evident. On high performance (race condition) applications, reinforcing the area around the mounting point of the crossmember is recommended. Always check the front engine mounts and replace if necessary.
