Congratulations! You have just purchased the best engineered, dyno-proven exhaust system available.

Part number SES1500TT
2017-2021 Honda Civic
Hatchback Sport Model ONLY
1.5L turbo 4cyl.
1- 3 piece cat back dual exhaust
1- triangle gasket (#12036)
2- 3.00 gasket (#17060)
4- M10 hex bolt (#6038)
4- M10 hex nut (#6069)
4- M8 Socket cap screw (#6076)

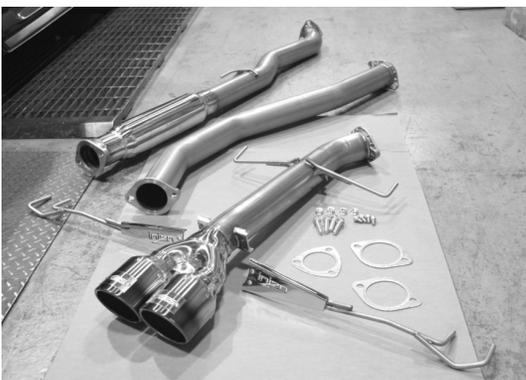
Figure 2

Complete kit:

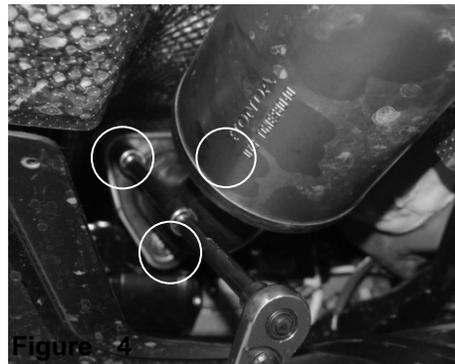
Figure 4

Loosen the 3 nuts holding in the pipe using 14 mm socket with wrench. Save these 3 nuts for later install.

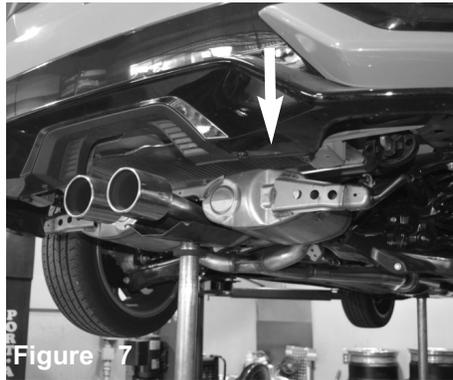
Figure 7

Carefully position and slide back and remove the exhaust out of the vehicle.

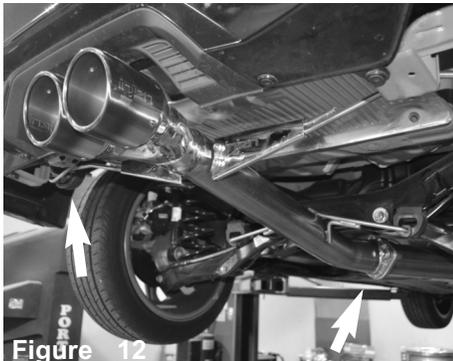
Figure 12

Position all the hangars to to the isolation mounts. **(look for UP sign on mount)** Position and adjust fitment. *Do not tighten.*

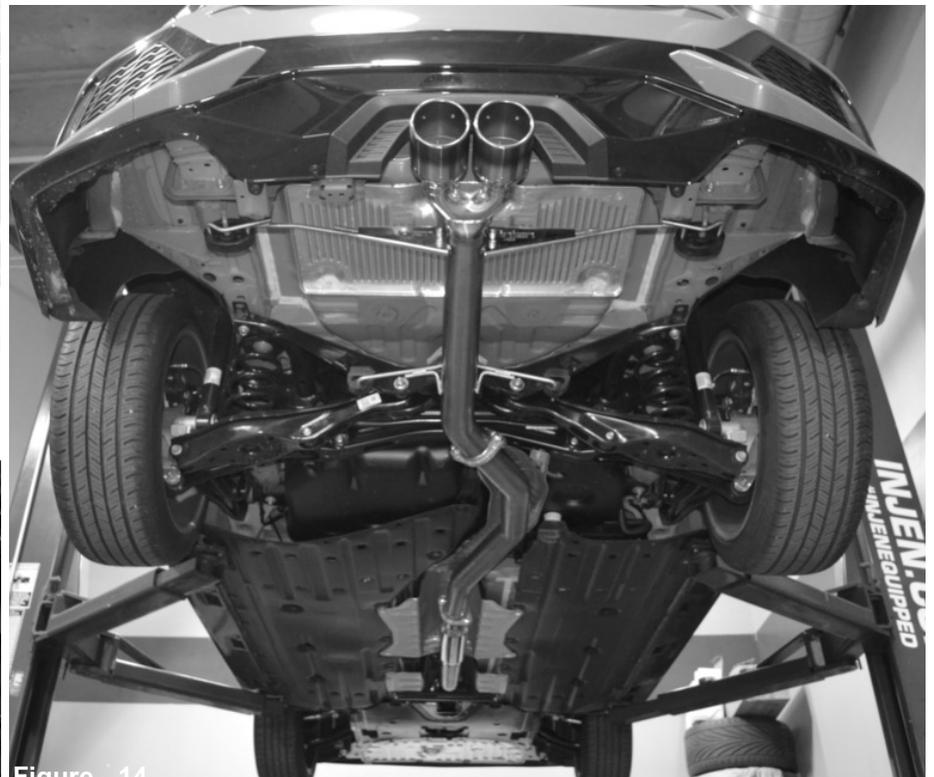
Figure 14

Congratulations! You have just completed the installation of this exhaust system. Verify and adjust the rear section of the exhaust, make sure muffler and tip do not touch any plastics or it can melt. Periodically, check the alignment of the exhaust, normal wear and tear can cause nuts and bolts to come loose. **Note: Check clearance and adjust if needed! Failure to check the alignment and adjust the exhaust can cause damage that will void the warranty. Injen Technology is not responsible for any damages caused by/from improper installation.**
