STAINLESS STEEL EXHAUST SYSTEM

Part Number: SES9300MD

Installation Instructions

YEAR	MAKE	MODEL	ENGINE
2021-2023	FORD	BRONCO (2DR & 4DR)	L4-2.3L TURBO
2021-2023	FORD	BRONCO (2DR & 4DR)	V6-2.7L TWIN TURBO

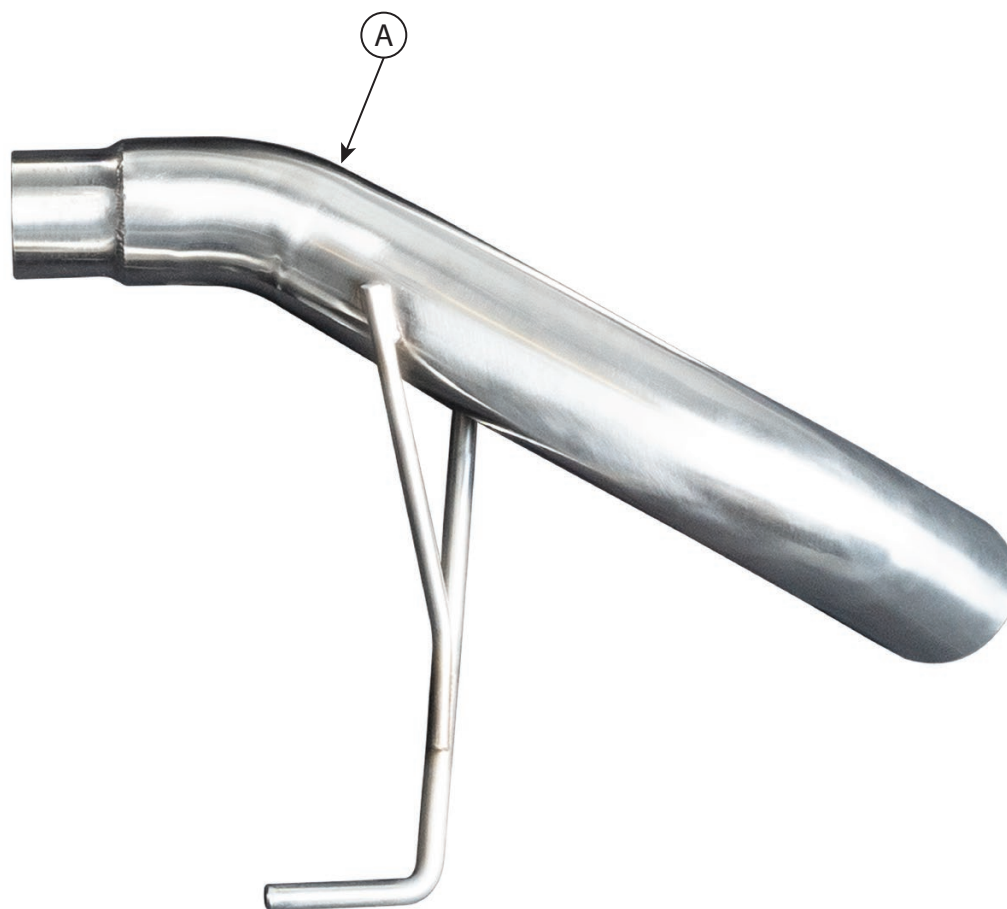
ITEM	QTY	PART NO.	DESCRIPTION
A	1	W-SES9300MD	Muffler delete pipe

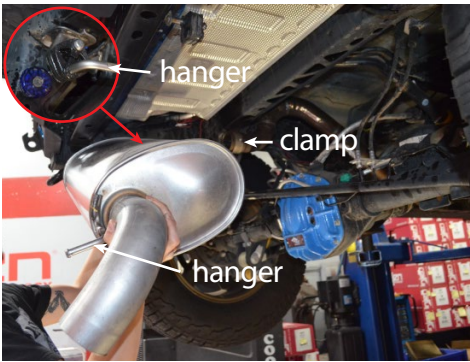
1. Remove the stock muffler by loosening the mid pipe clamp and detaching the muffler from the rubber insulators.

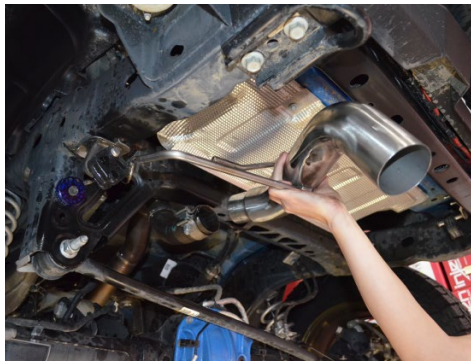
2. Insert the hanger to the rubber insulator then connect the muffler delete pipe to the mid pipe.

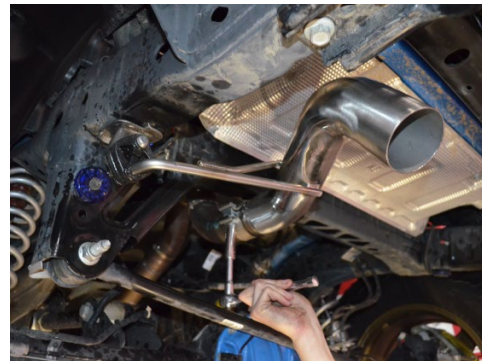
3. Secure the muffler delete pipe using the OEM clamp.
