Instructions

Replacement Front Control Arms

Application - VW Golf - MK5/6/7
- Audi A3 (MQB platform)

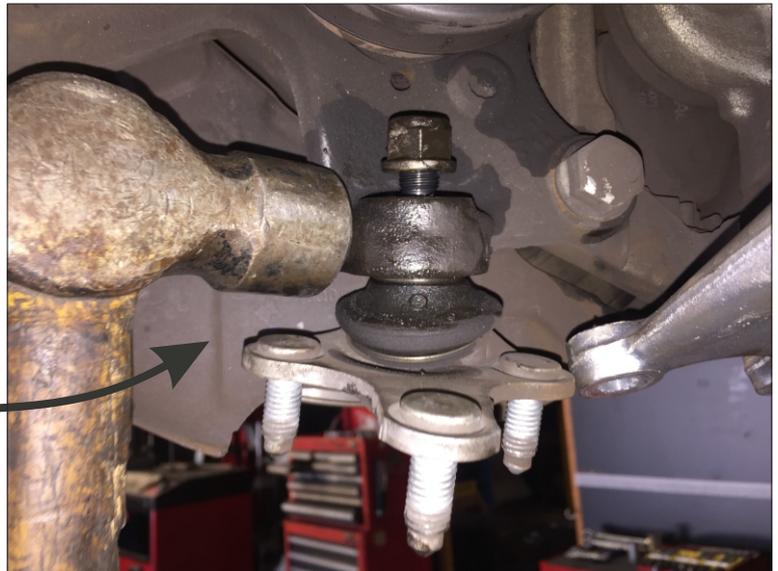
- Proceed to remove front wheels.
- Start by loosening both control arm bolts.
- Loosen main upper Ball Joint nut (do not remove yet)
- Strike hub until Ball Joint dislodges.

Refer RH image. Note this is an image of a vehicle with steel hubs

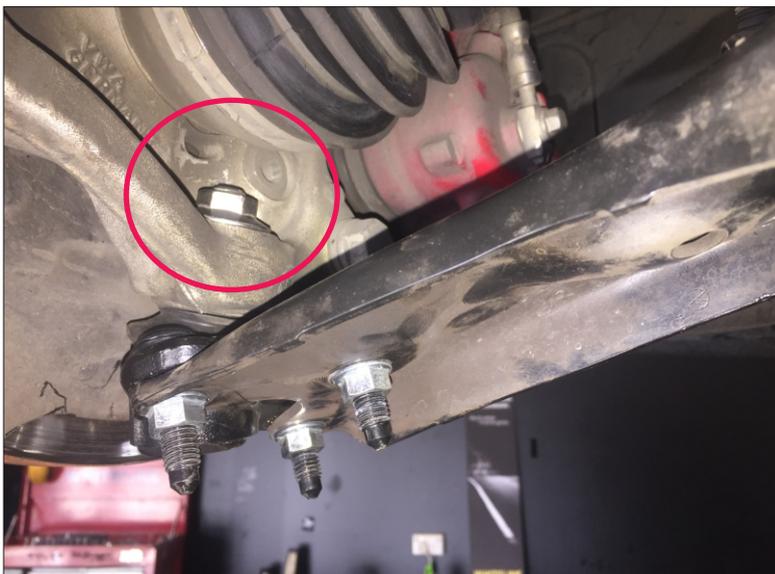
Vehicles equipped with aluminium hubs MUST reuse original flanged nut.

Refer LH image.
